IRRIGATION AUDIT

“WATER DISTRIBUTION AND
UNIFORMITY EFFICIENCY
ANALYSIS”

**TIERRA RIDGE
COUNTRY CLUB**

AUGUST 2013

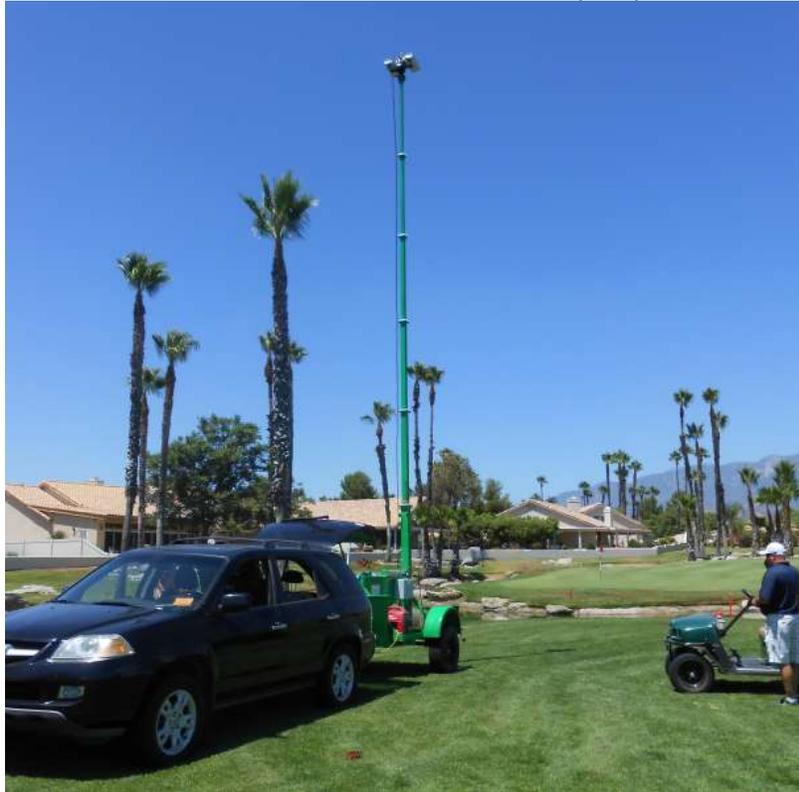
Portable Trailer Mounted Hawk-Eye System

The portable Hawk-Eye System can be powered by a small generator or batteries and is operated with a telescoping mast that can be raised to 35-50 feet for better perspective of the areas being viewed and studied.

The Hawk-Eye System is a high quality, high resolution camera system with a very high pixel density capable of high resolution clear visual color, and thermal (far-IR) photographic images. The unit transmits its photo images locally by Wi-Fi hot spot and via a cellular card to the Internet.

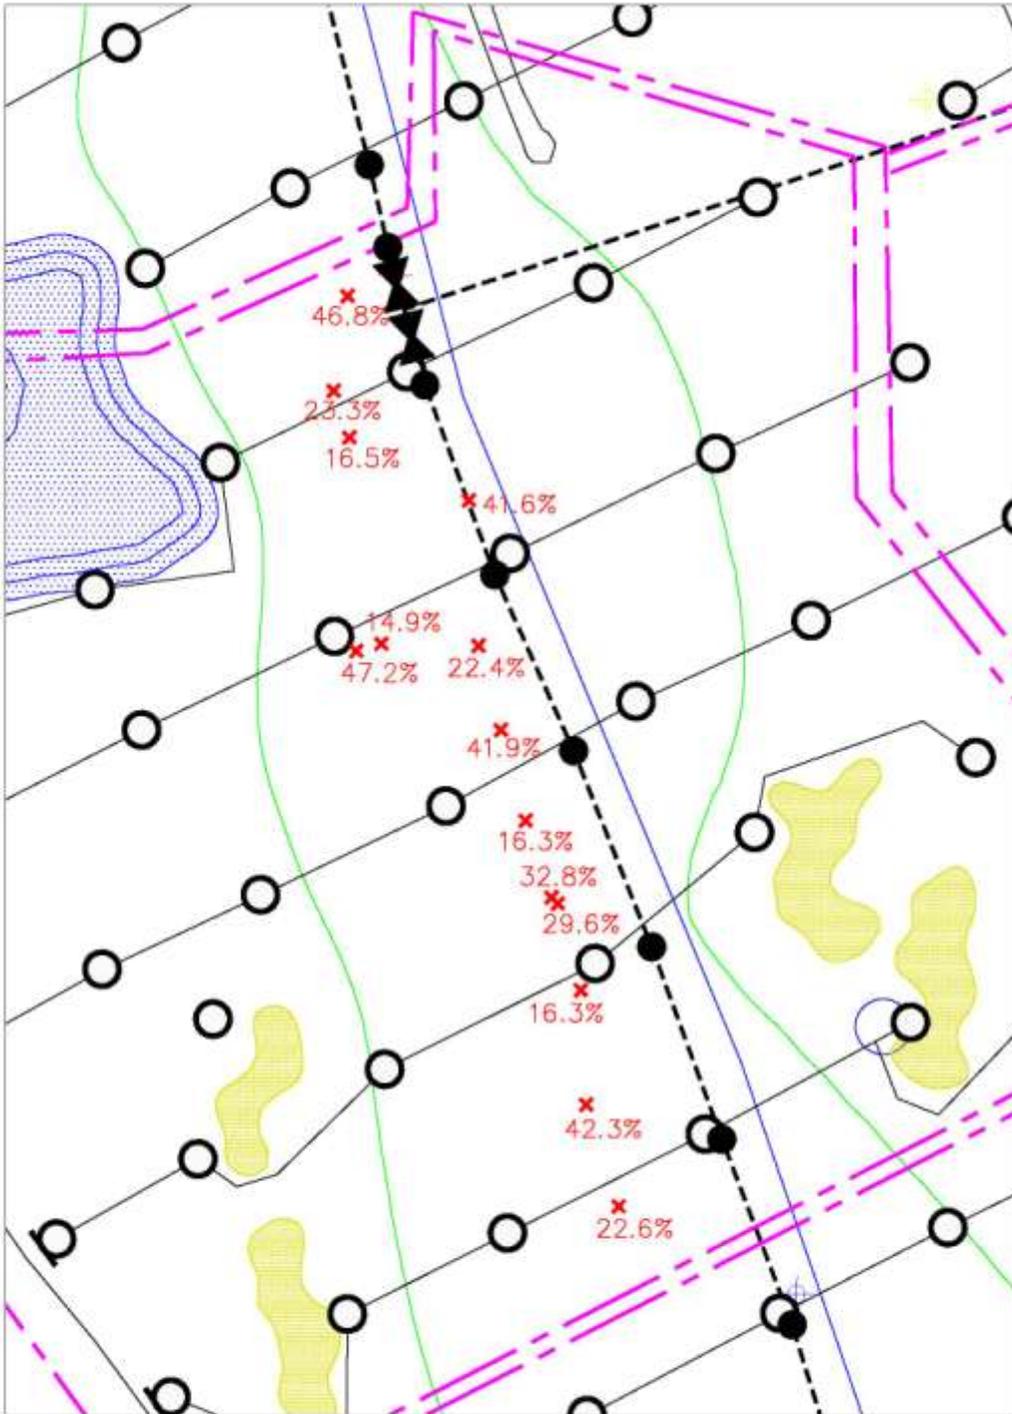
#9 Fairway – Soil Moisture Percentage

An ‘as-built’ drawing of the irrigation system and data collection points are provided on page 6.

For the definable patterns in the mosaic imagery we measured representative canopy temperatures and soil moisture percentages (page 6) to quantify the differences for each of the areas of distinguishable color groups.

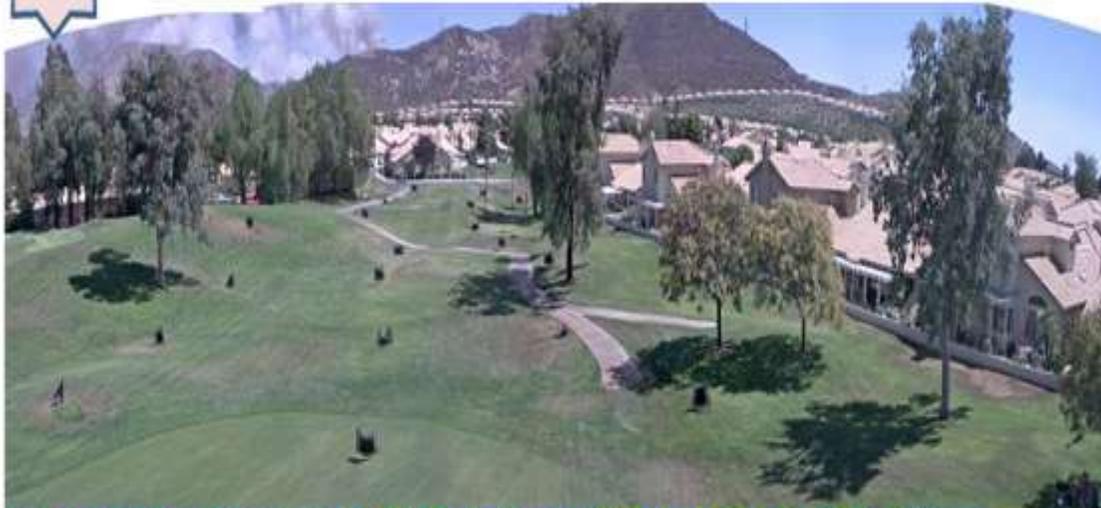
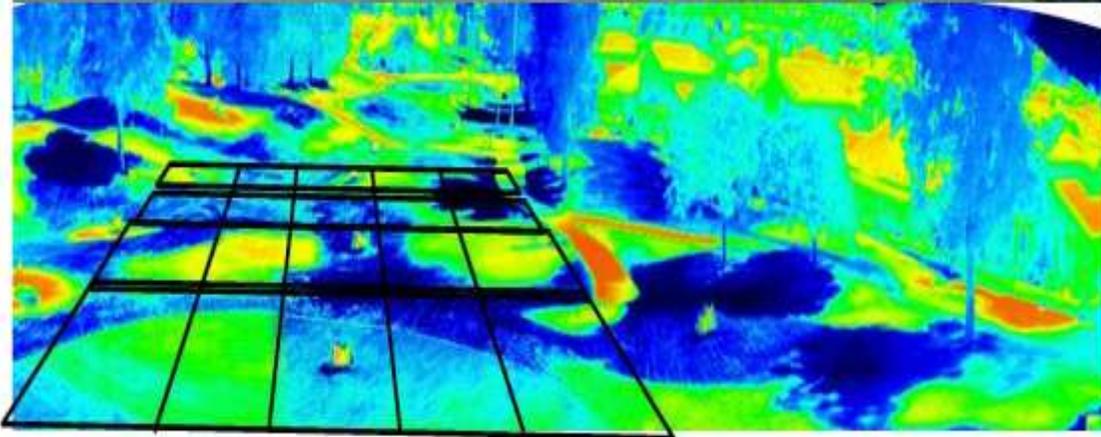
FACING TEE ON HOLE # 9

The Hawk-Eye was set up at four imaging stations on #9 fairway and collected both thermal (far-IR) and visual color photos. By placing reflective banners next to each irrigation head that are viewable in the thermal and the visual imagery it is possible to relate the thermal signatures of the fairway to individual irrigation sprinklers and the water/soil moisture patterns can be directly inferred.

Classification	Canopy Temperature	% Coverage in Fairway
Orange (very warm // infer very dry)	104° F	10
Yellow	98° F	15
Green	94° F	30
Light Blue	90° F	25
Blue (cool // infer very moist)	86° F	20

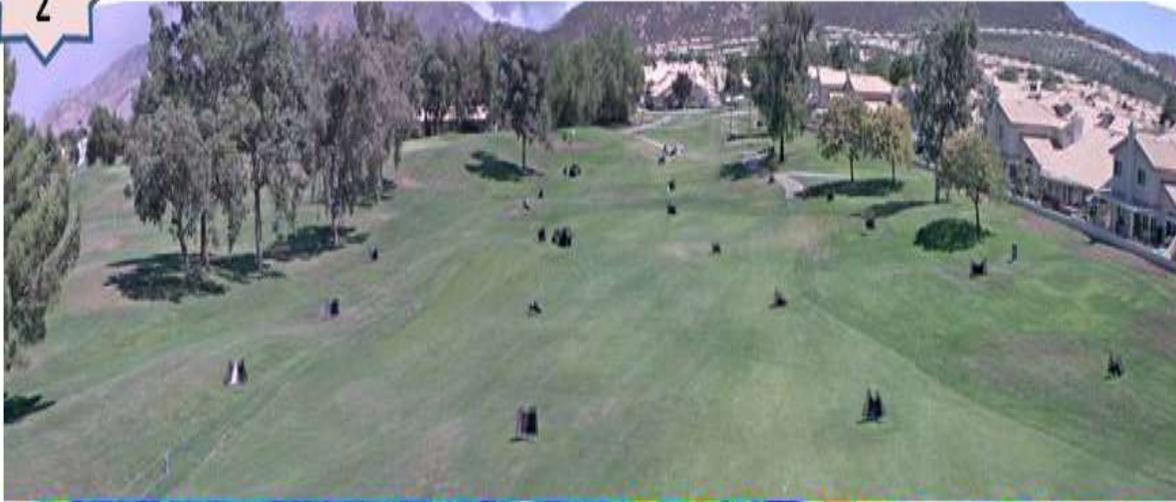
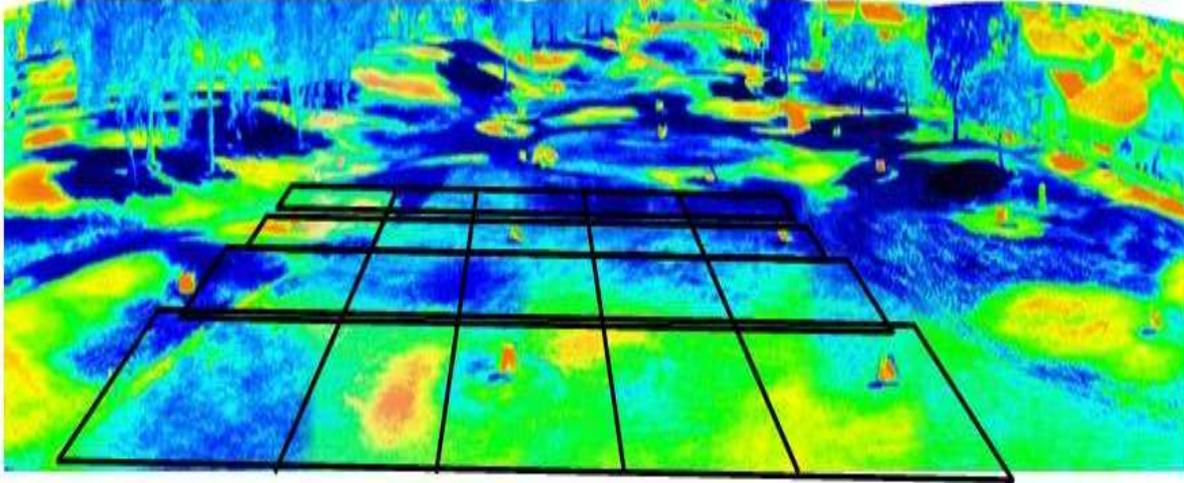
Location
2

FACING TEE ON HOLE # 9

Classification	Canopy Temperature	% Coverage in Fairway
Orange (very warm // infer very dry)	104° F	10
Yellow	98° F	5
Green	94° F	30
Light Blue	90° F	40
Blue (cool // infer very moist)	86° F	15

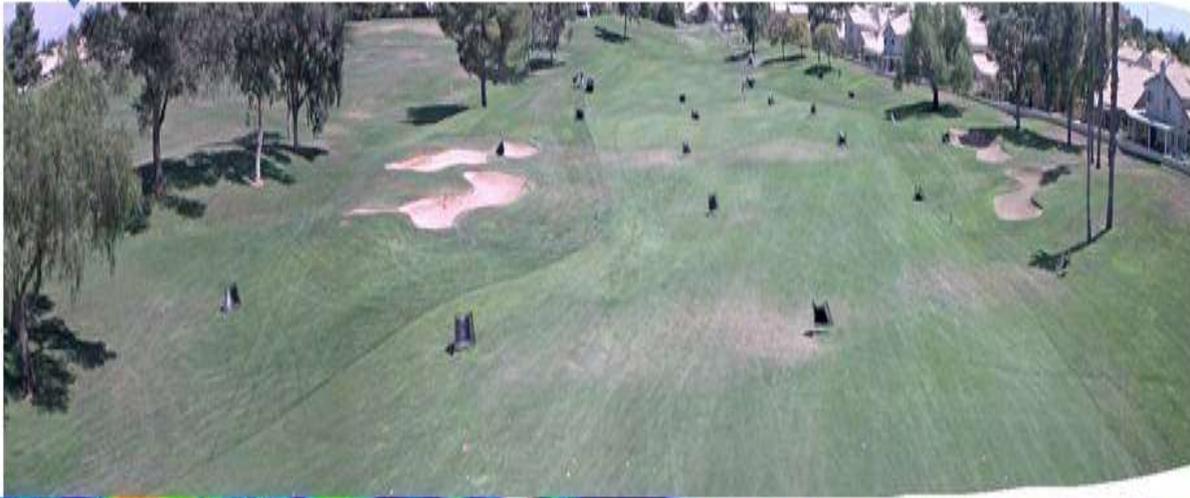
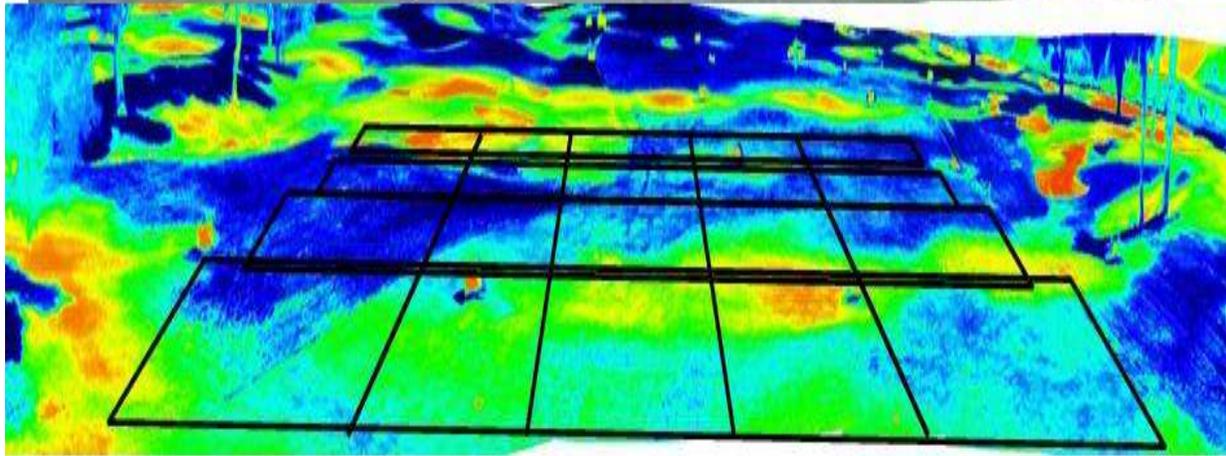
FACING TEE ON HOLE # 9

Classification	Canopy Temperature	% Coverage in Fairway
Orange (very warm // infer very dry)	104° F	5
Yellow	98° F	5
Green	94° F	35
Light Blue	90° F	25
Blue (cool // infer very moist)	86° F	30

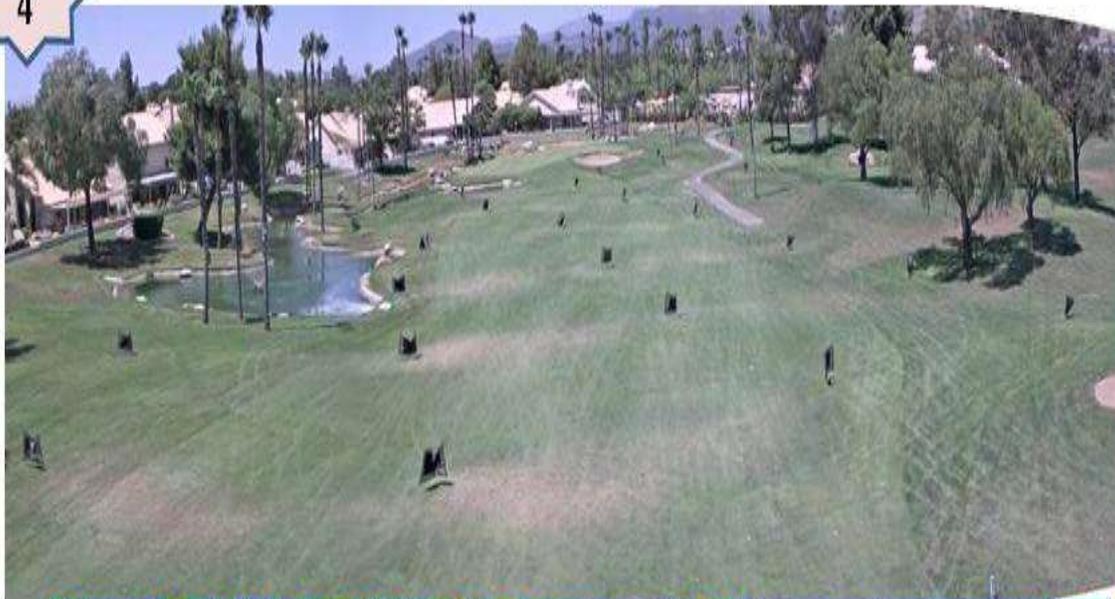
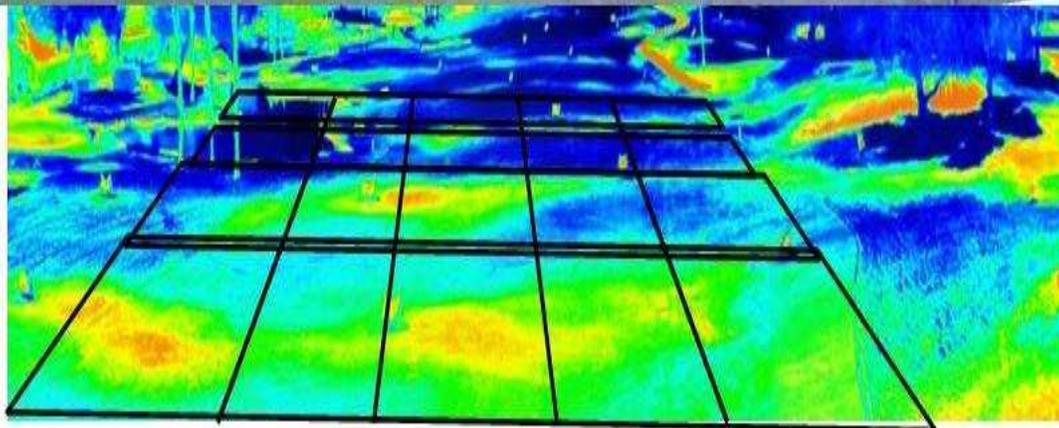
Location
4

FACING GREEN ON HOLE # 9

Classification	Canopy Temperature	% Coverage in Fairway
Orange (very warm // infer very dry)	104° F	15
Yellow	98° F	5
Green	94° F	30
Light Blue	90° F	15
Blue (cool // infer very moist)	86° F	35

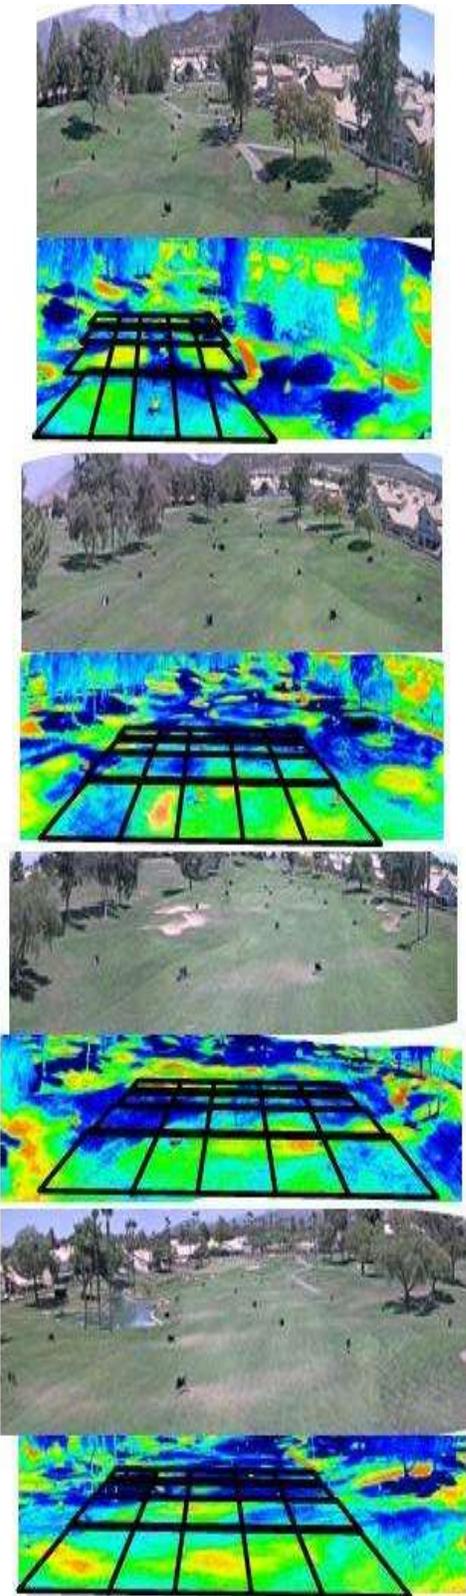
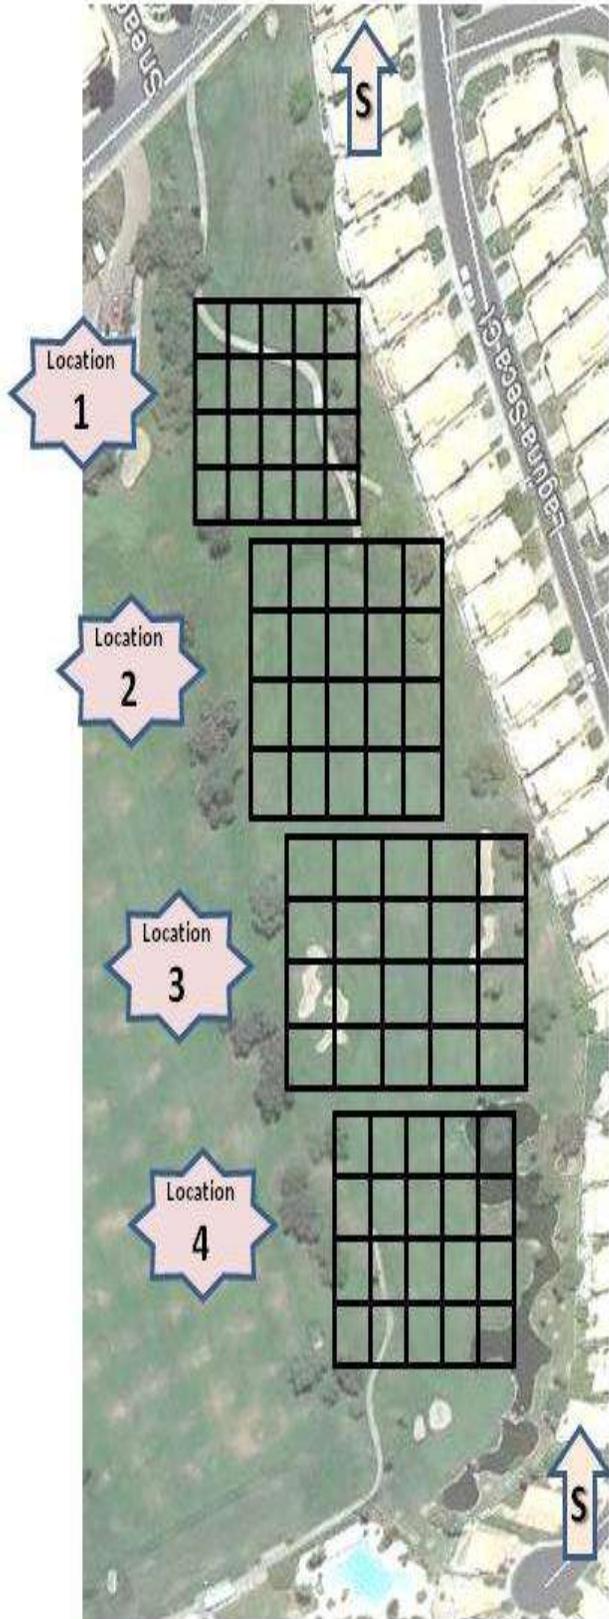
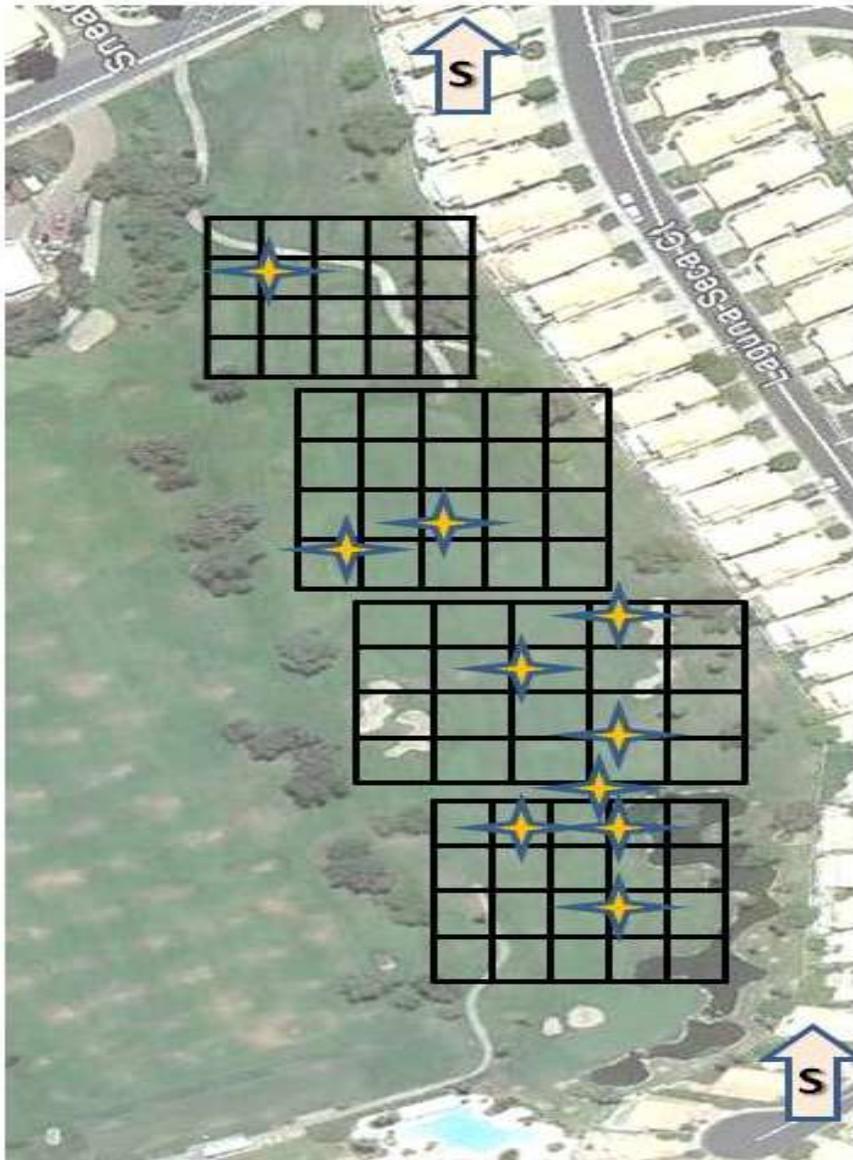
Overall Classification	Canopy Temperature	Inferred Moisture (% WC)	% Coverage in Fairway

Orange (very warm // infer very dry)	104° F	16 %	10 %
Yellow	98° F	23 %	10 %
Green	94° F	30 %	30 %
Light Blue	90° F	37 %	25 %
Blue (cool // infer very moist)	86° F	44 %	25 %

In reviewing the collected data illustrated on pages 13-14 the analysis shows that there is approximately 40 acres (20%) of the two golf course that shows signs of water stress, whereas over 100 acres (50%) have moisture above optimal condition.

We strongly recommend that the replacement of the pump station along with a comprehensive review of the entire irrigation system (hydraulic system, irrigation head and their nozzle performance, irrigation head placement and spacing along with the sprinkler field satellite function and location and the function and effective use of the central control system and associated wiring).
